# Debris/Ice/TPS Assessment And Photographic Analysis For Shuttle Mission STS-44

Gregory N. Katnik  
NASA/Kennedy Space Center

November 24, 1991

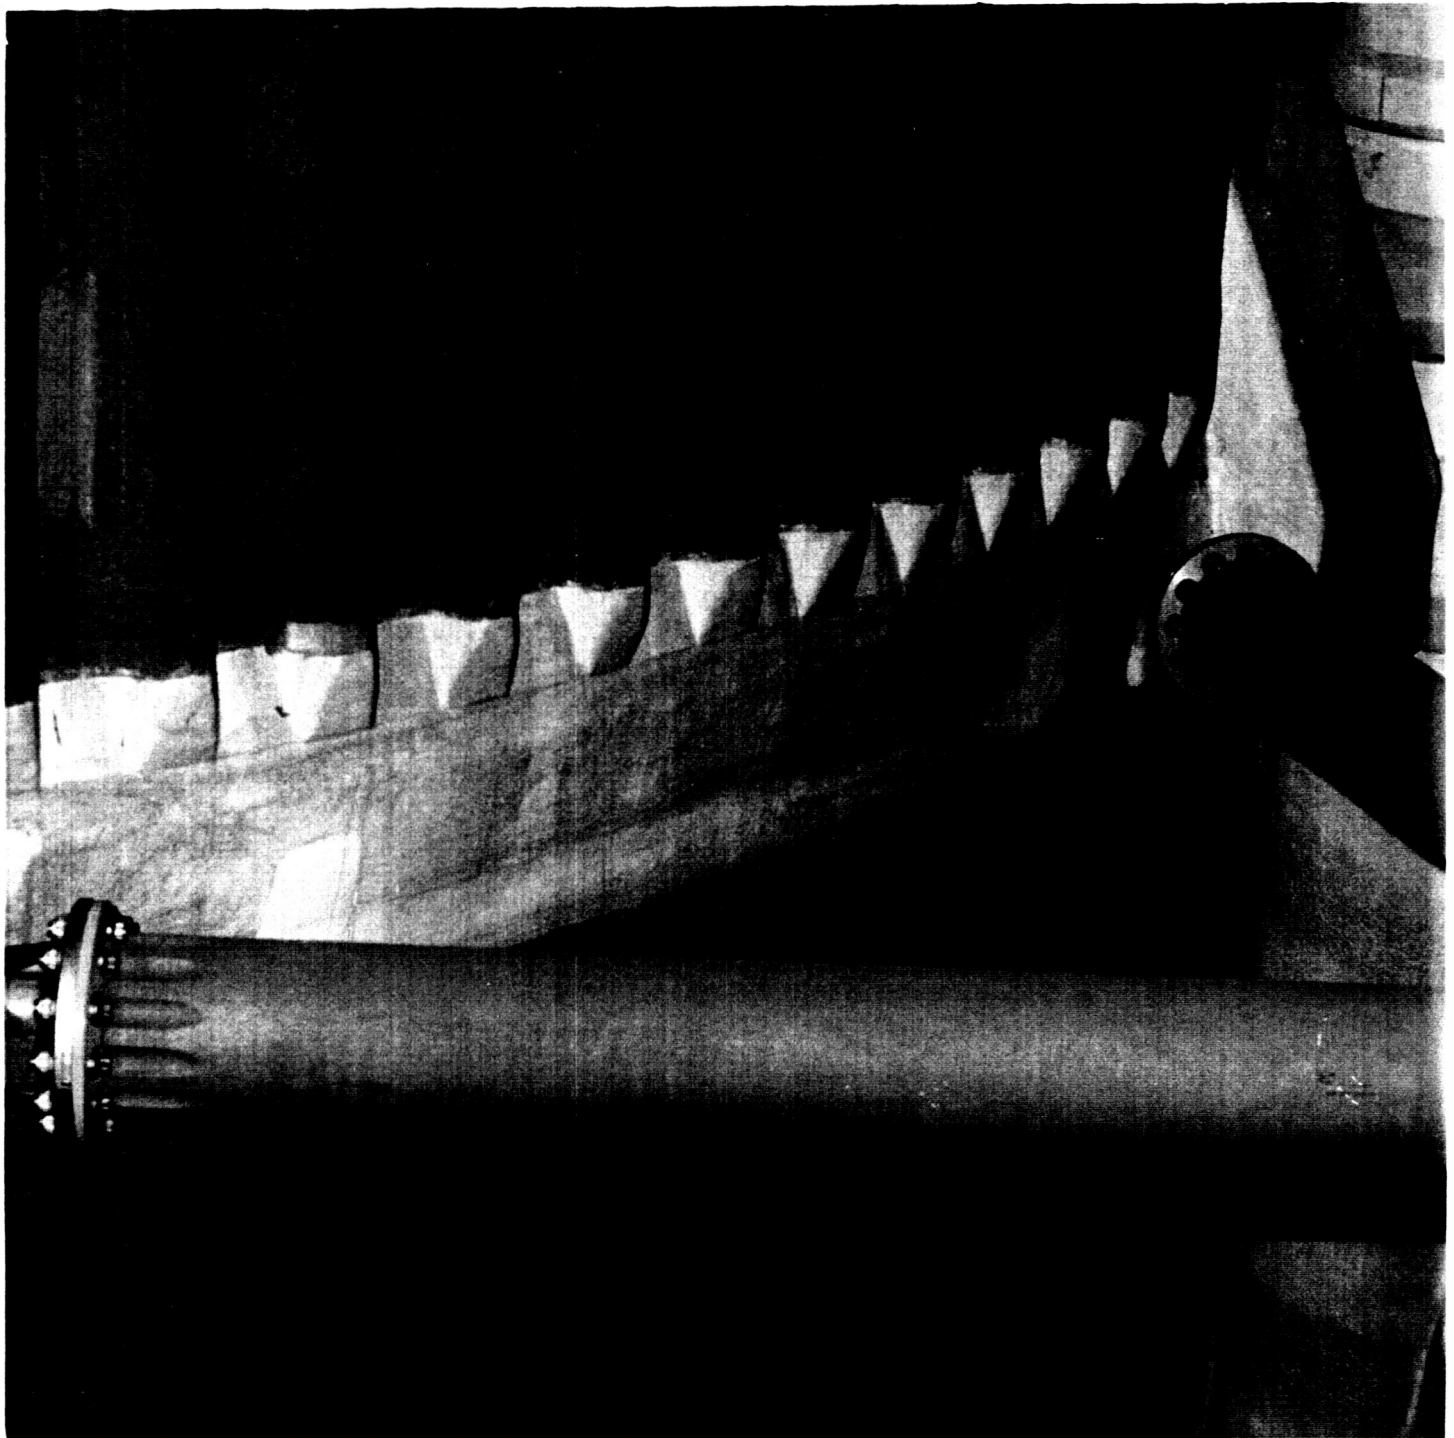
Pre-launch configuration of bipod jack pad closeouts. After cryogenic loading, a frost ball formed on the bondline of the +Y bipod jack pad closeout at the 4 o'clock position. Presence of the frost ball at this location was not a constraint to launch per NSTS-08303.

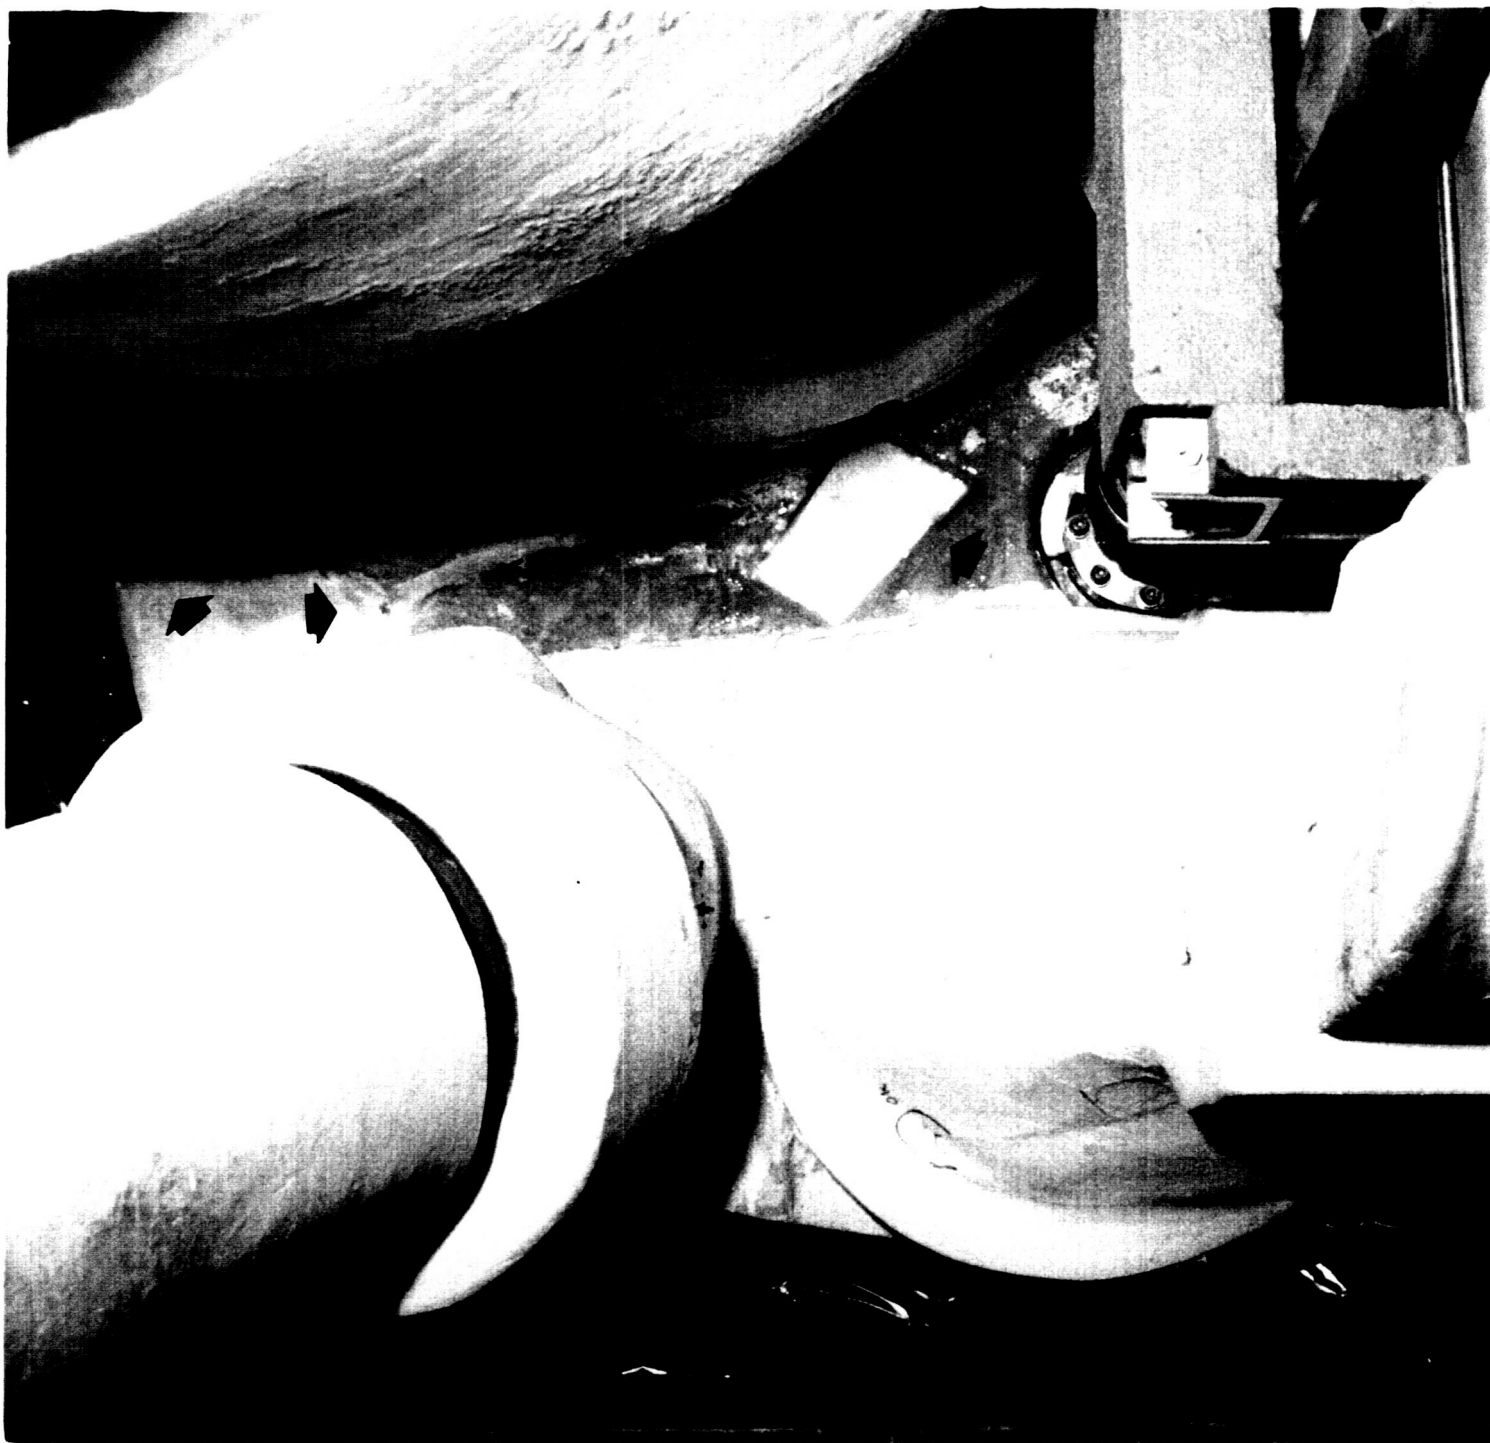
Pre-launch view of LH2 feedline 17-inch flapper valve actuator tool access port closeout and thin foam area around LH2 umbilical aft pyrotechnic canister closeout.

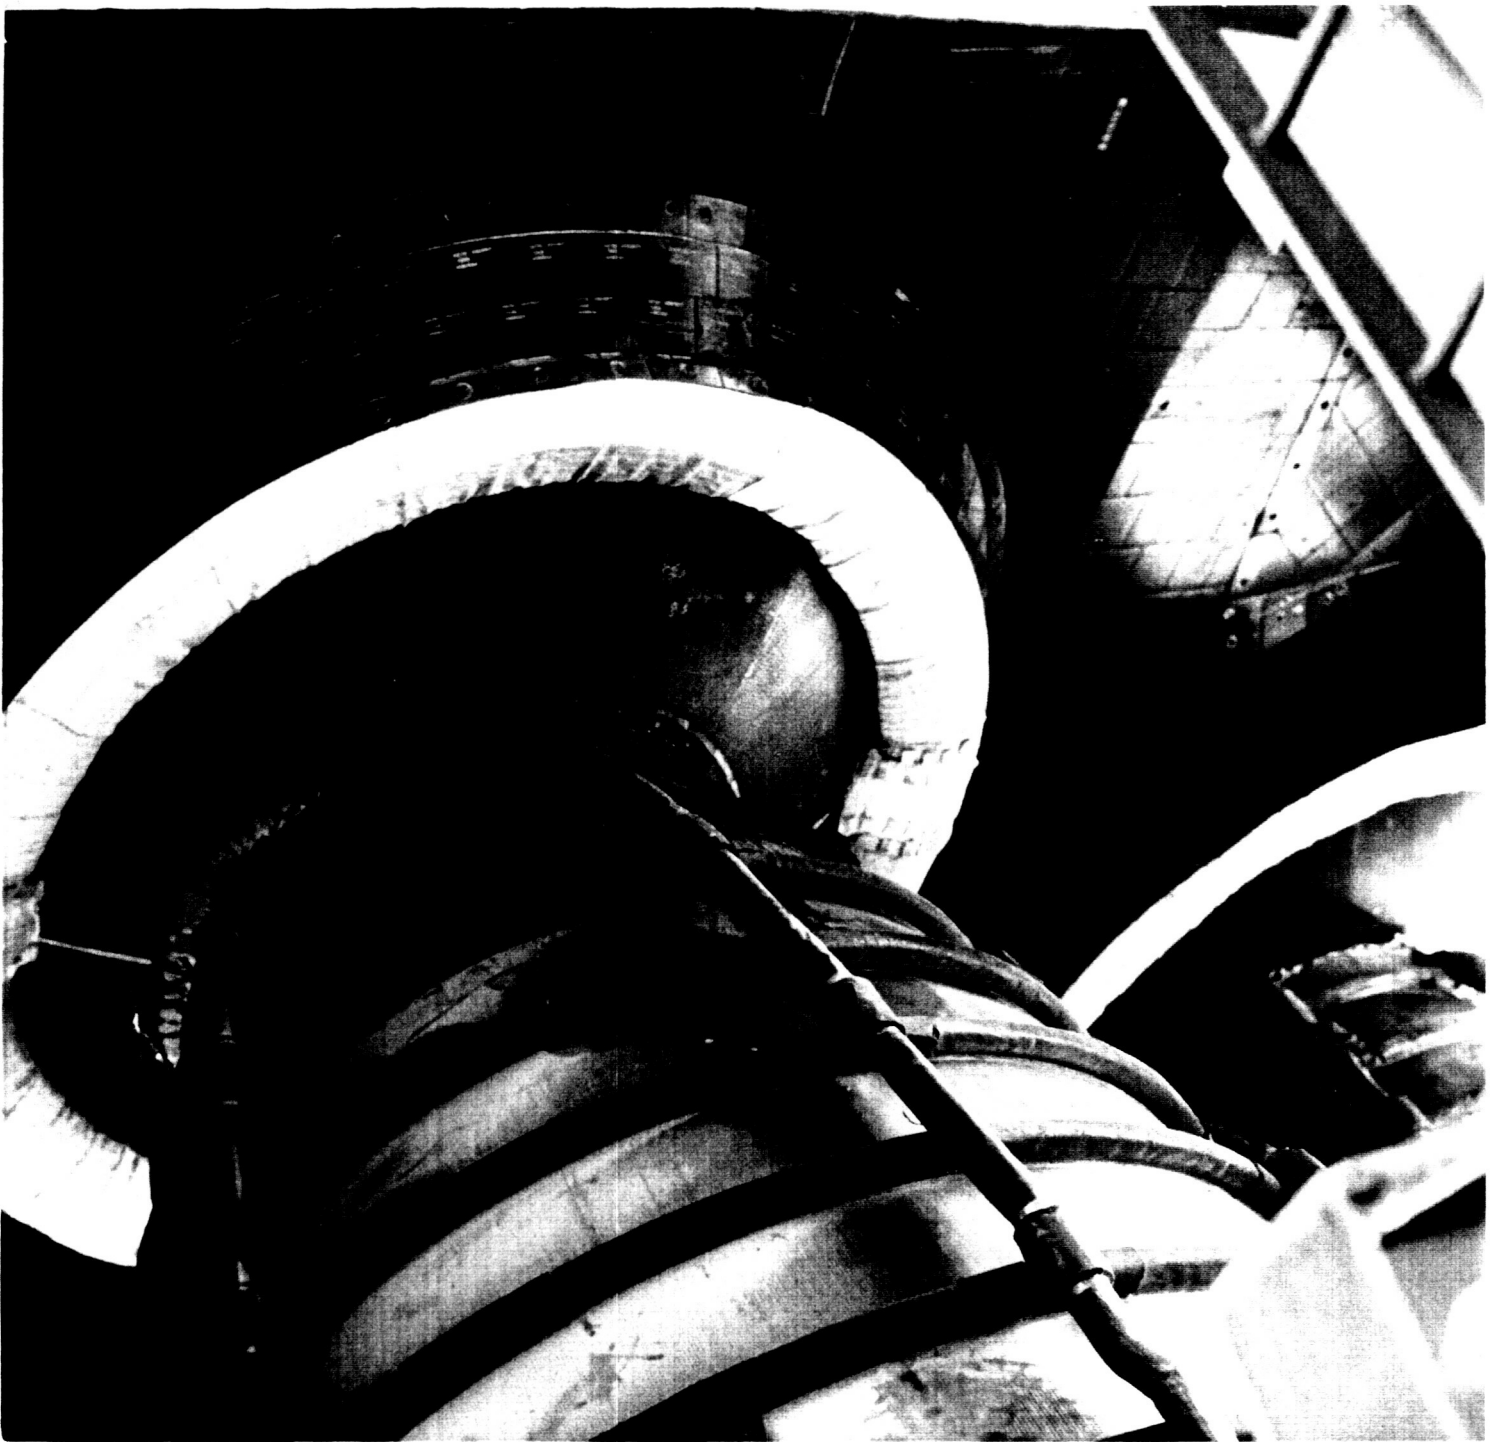
Overall view of SSME's. Some ice/frost had formed at the  
SSME heat shield-to-nozzle interfaces.

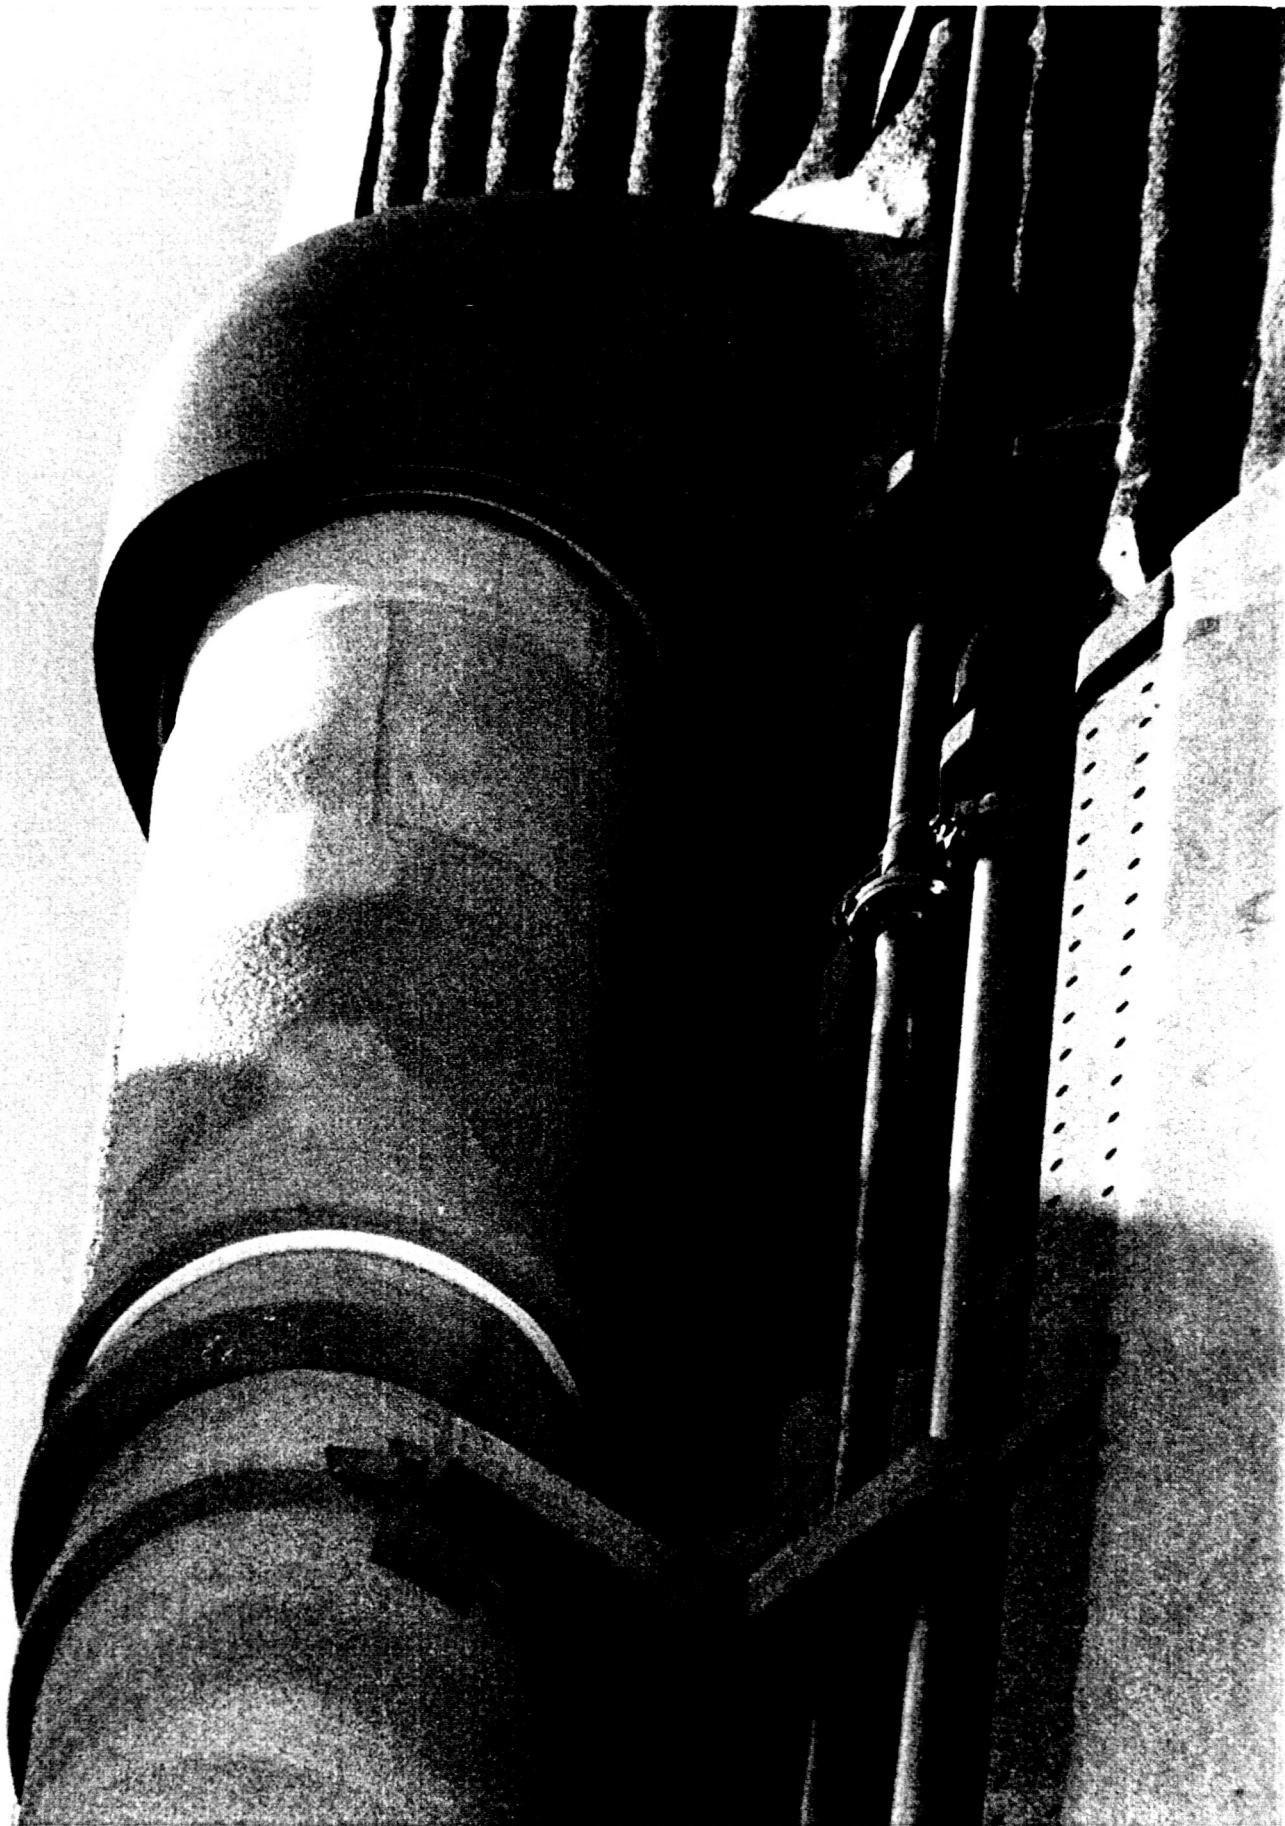
Ice/frost accumulations in the LO2 feedline upper bellows  
and support brackets were typical

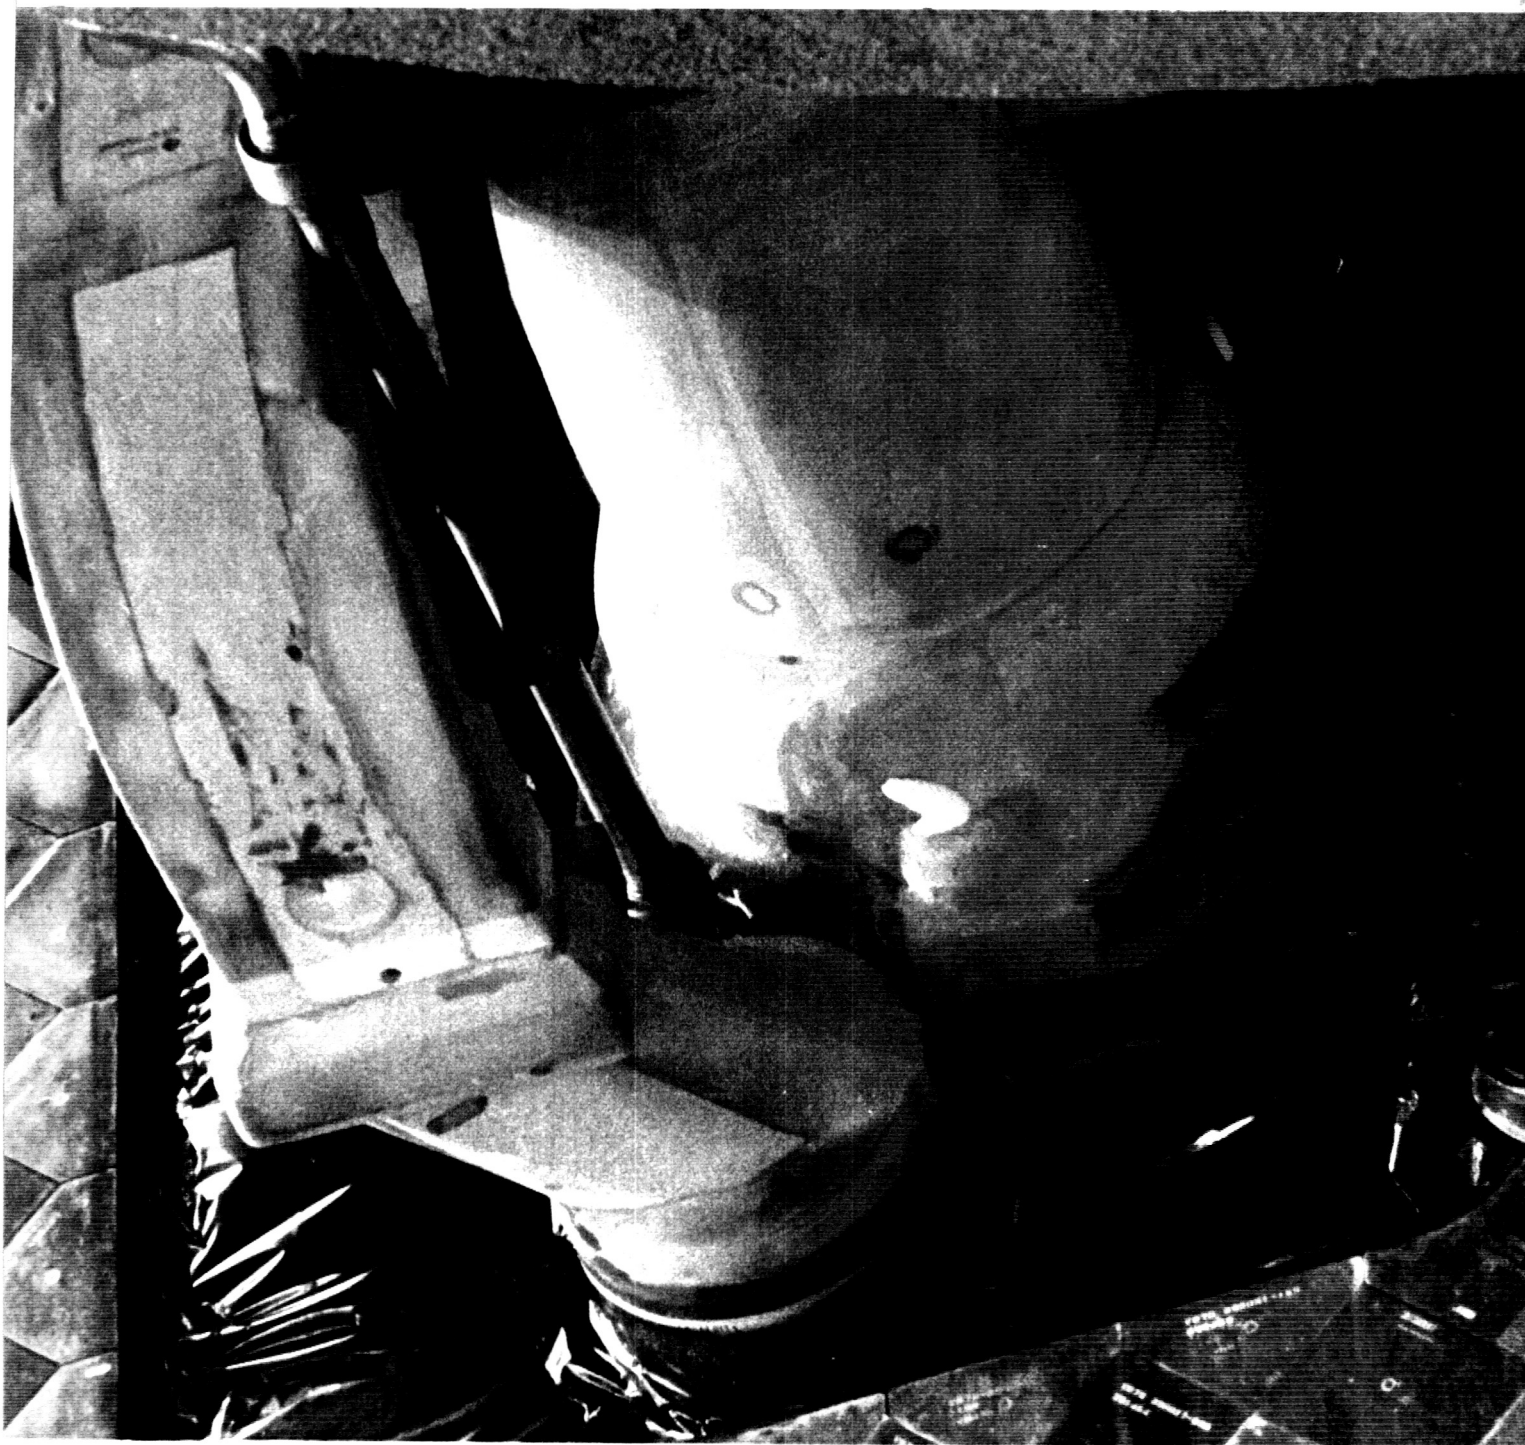
Overall view of the L02 ET/ORB umbilical. Ice/frost fingers on the pyro canister purge vents were typical. There were no acreage TPS anomalies or ice/frost accumulations.

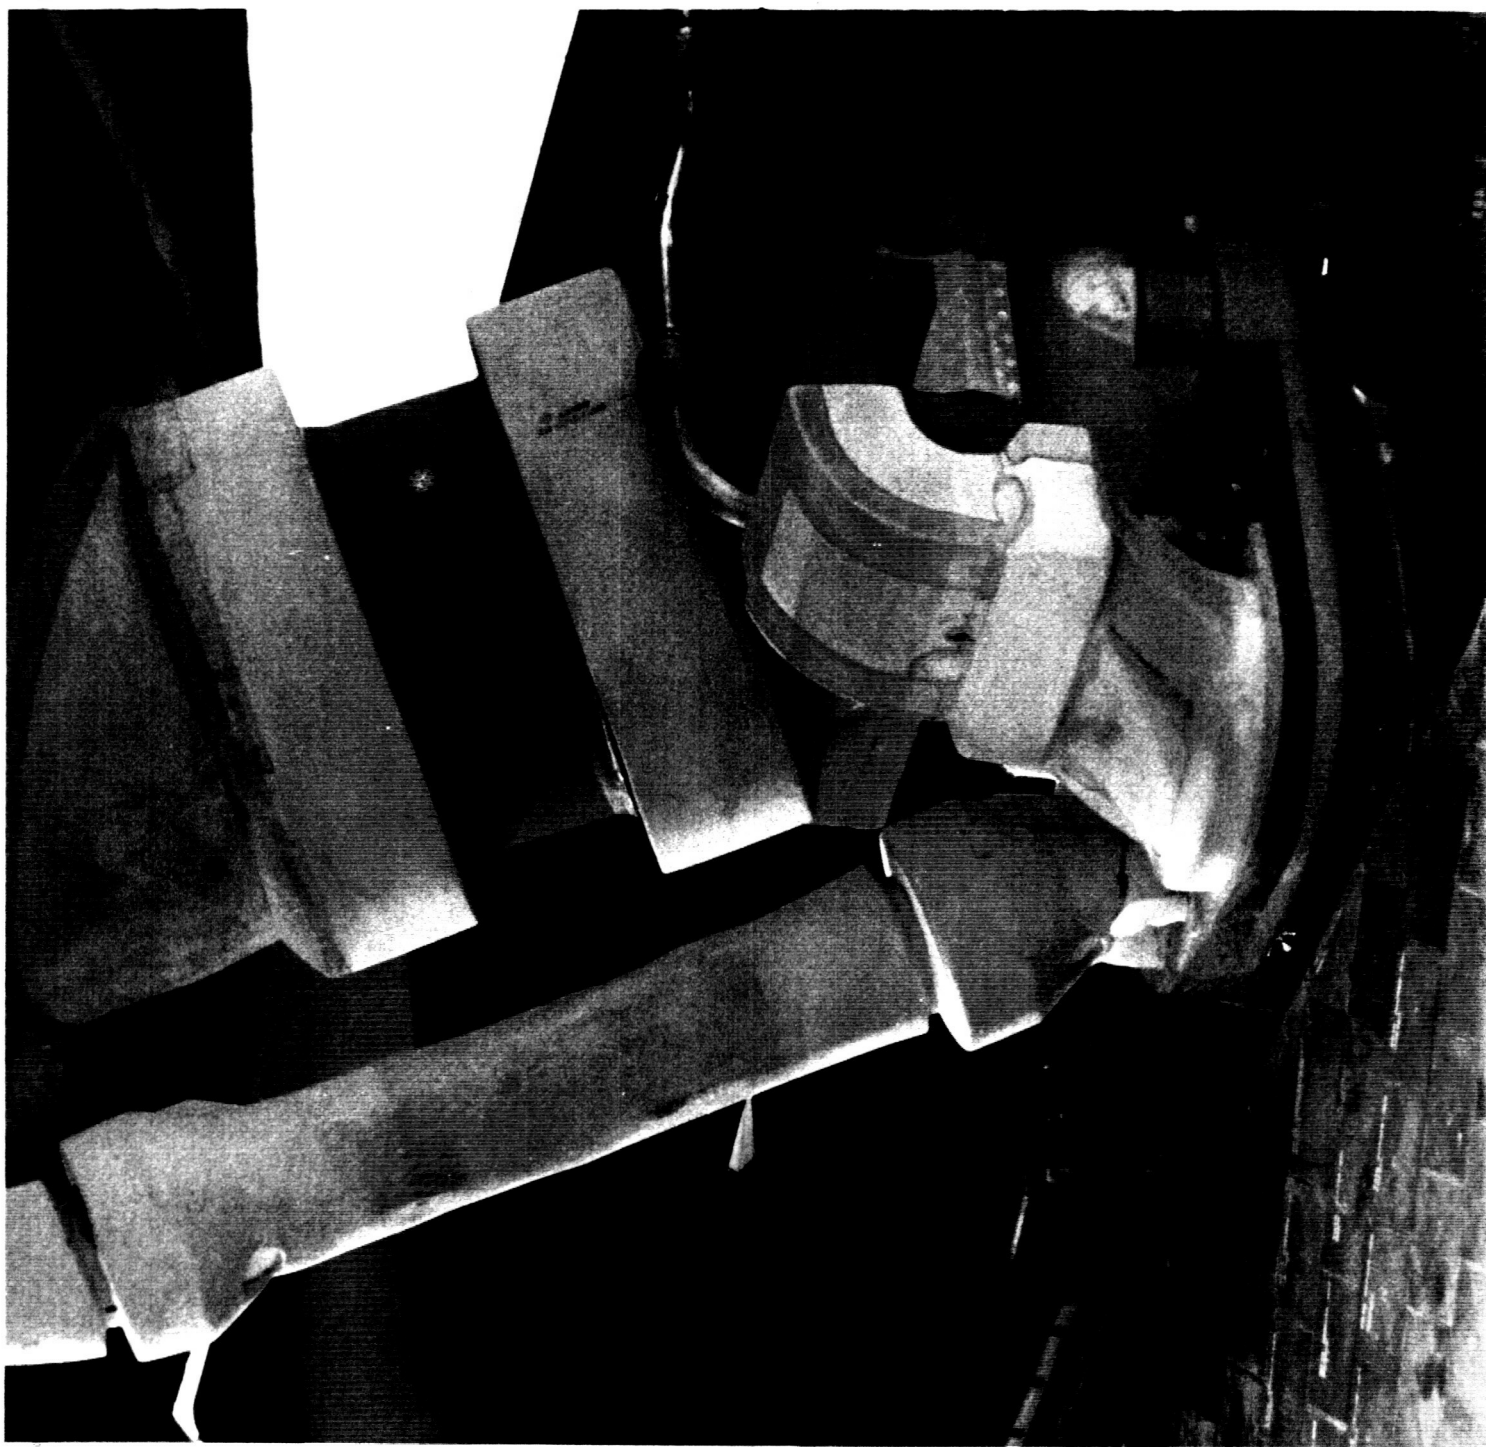
Overall view of the LH2 ET/ORB umbilical. There were no unusual vapors emanating from the umbilical nor any evidence of cryogenic drips. Ice/frost accumulations in the recirculation line bellows, on the burst disks, on the umbilical purge vents, and on the top side of the umbilical were typical. Although typically present for most cryogenic loadings, no ice/frost had formed on the outboard and aft sides of the umbilical/purge barrier (baggie).

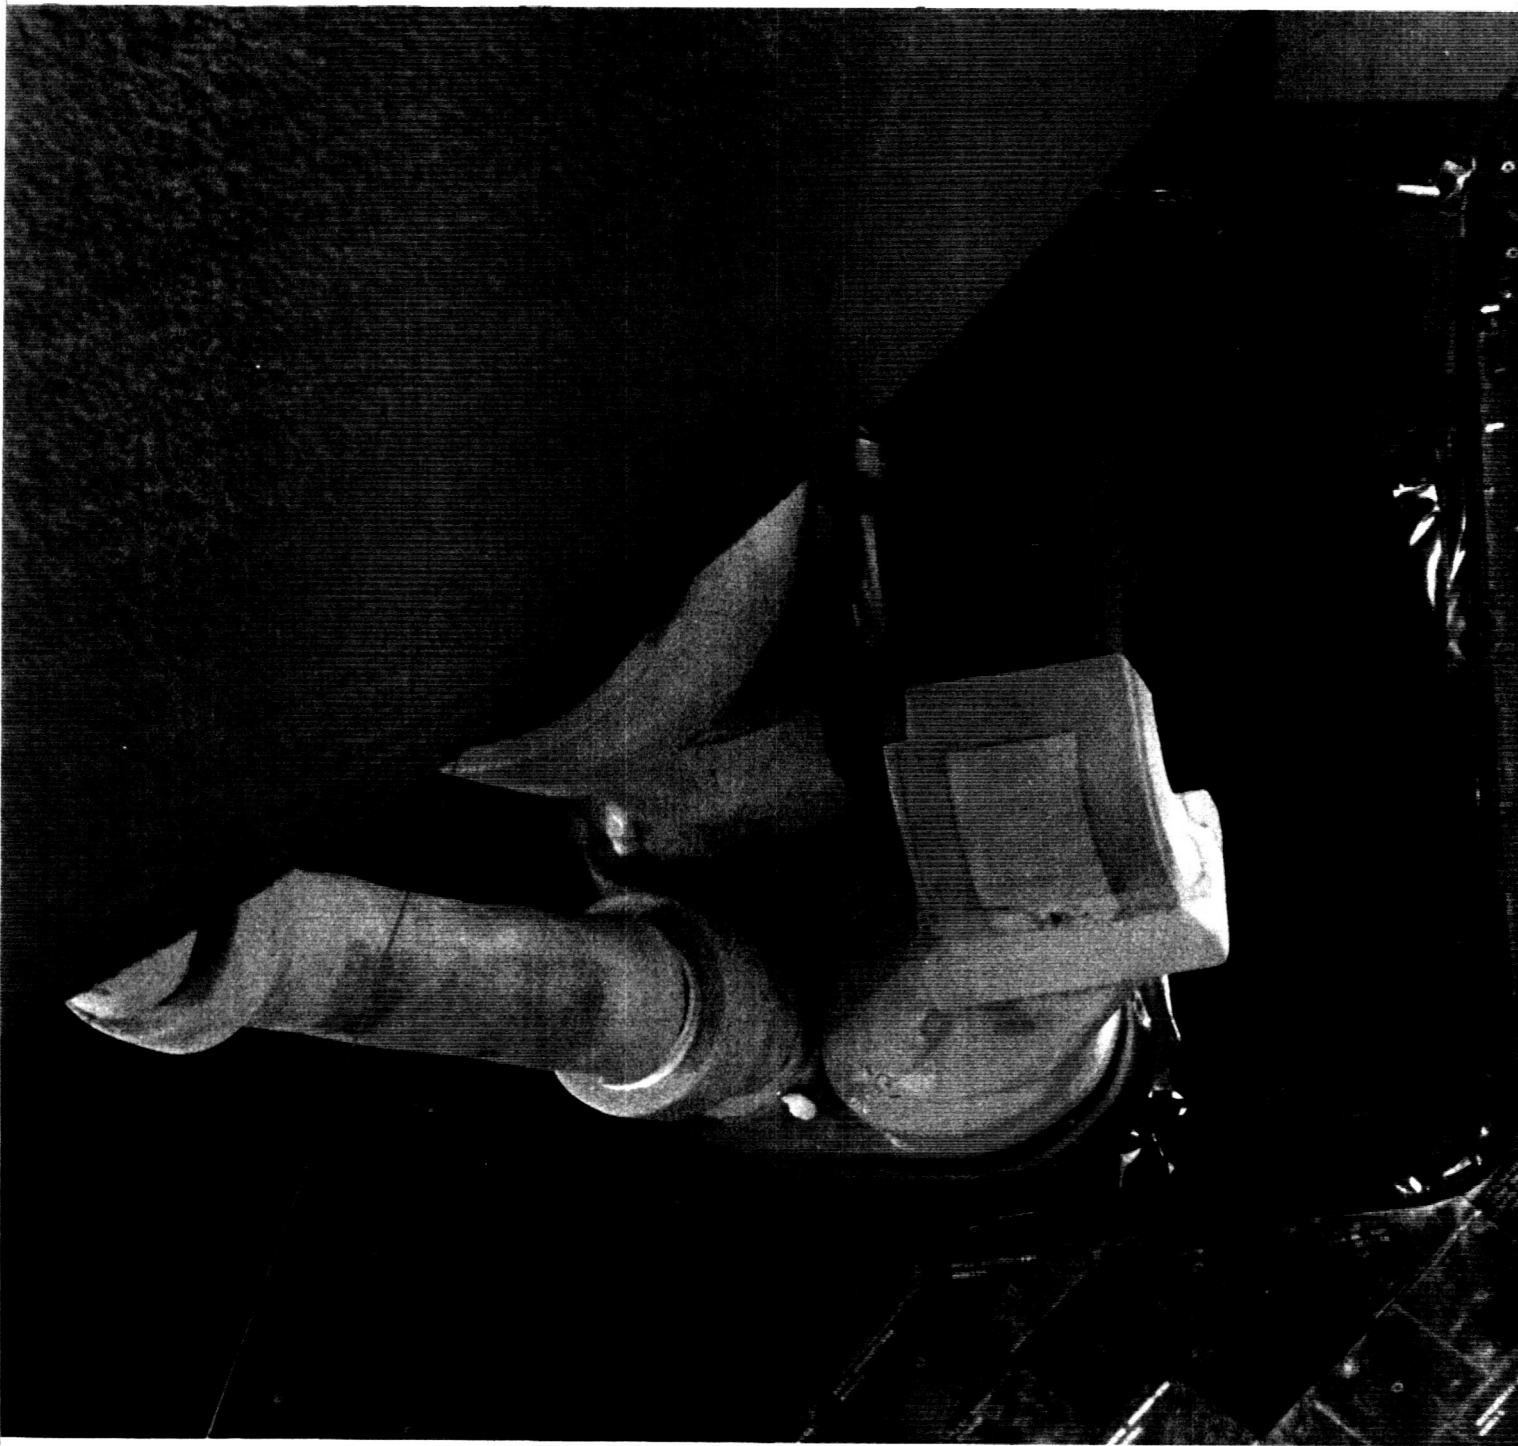
Less than usual ice/frost had accumulated on the inboard and aft sides of the LH2 ET/ORB umbilical. Ice/frost formations on the lower plate gap purge vent and in the LH2 recirculation line bellows were typical. The cable tray vent hole and 17-inch flapper valve actuator tool access port closeout exhibited no ice or frost accumulations.

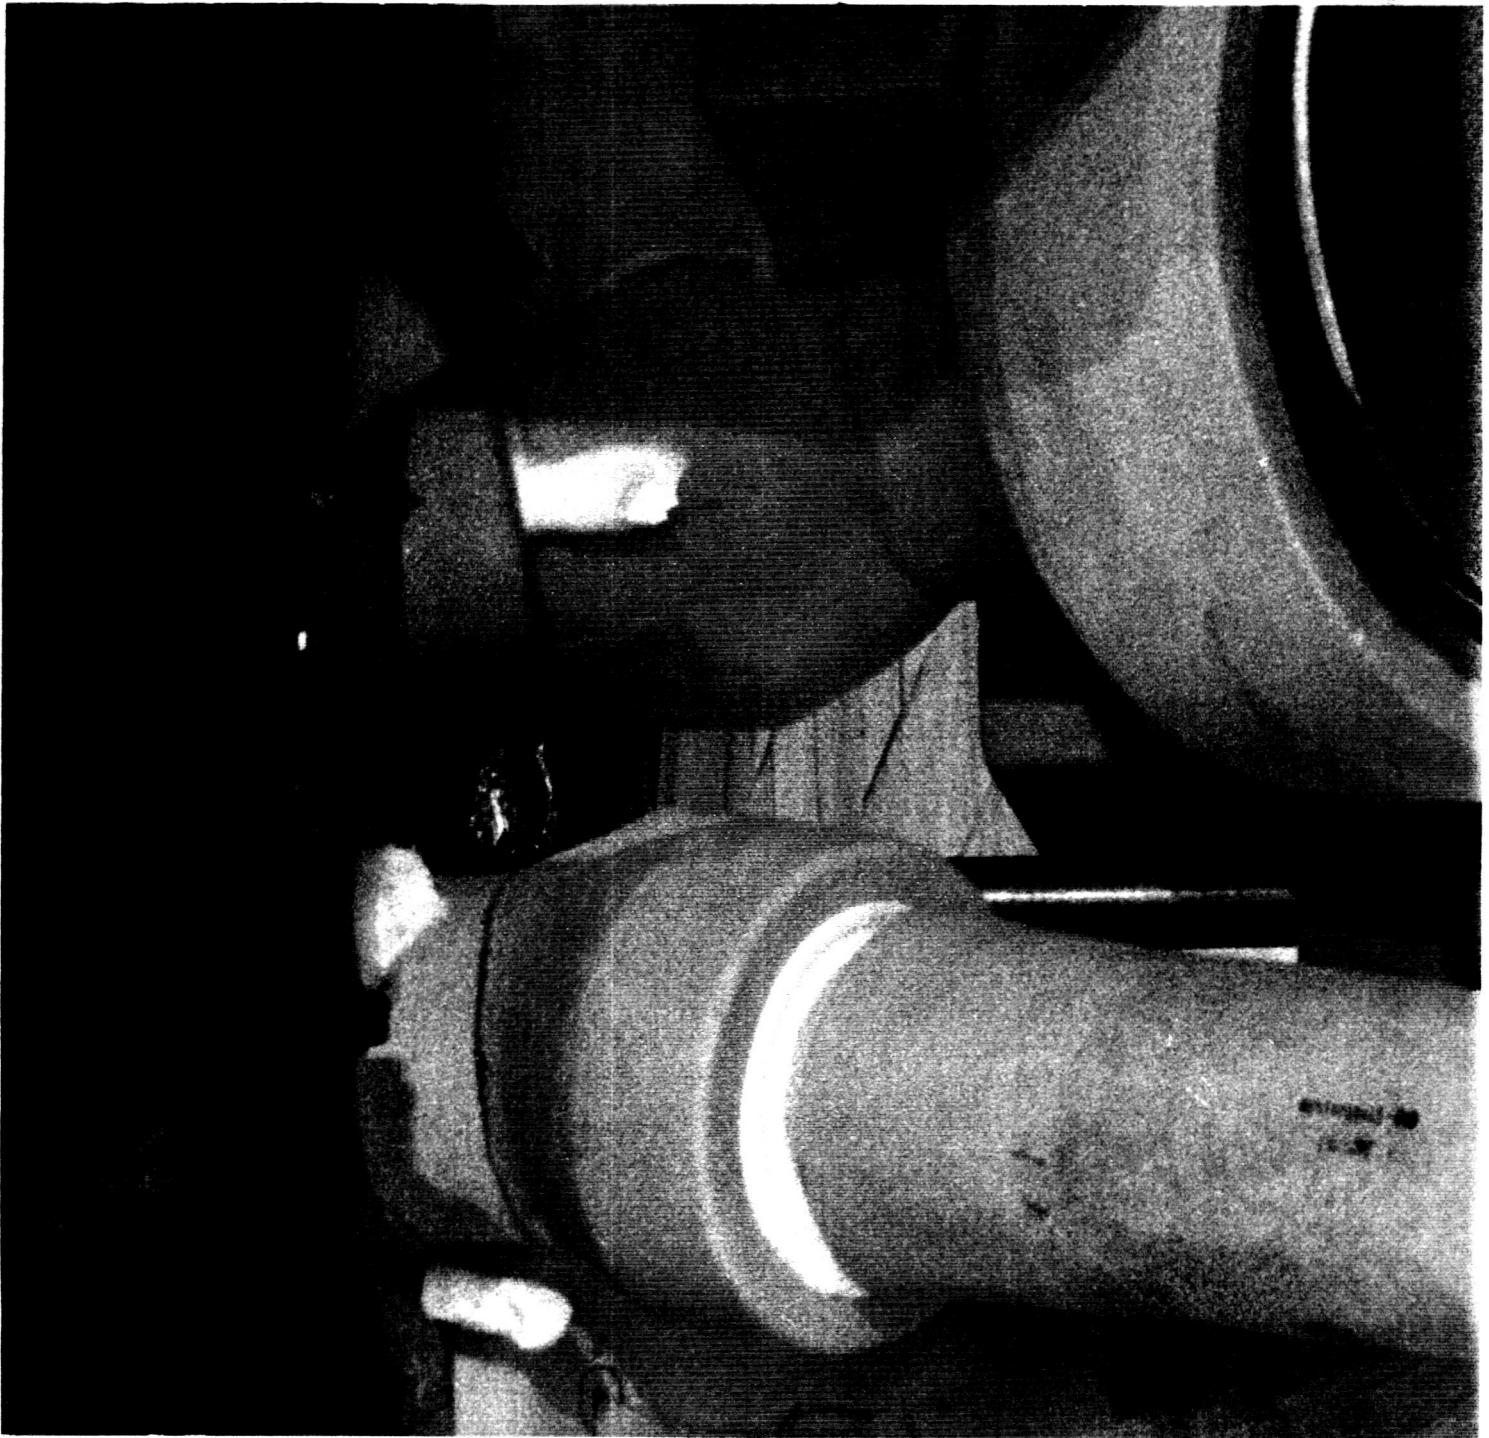
A small amount of ice/frost had formed on the aft area of the LH2 umbilical and on the aft pyrotechnic canister inboard bondline. Thin foam exists in this area due to an incorrect mold manufacture. The amount and location of the ice/frost was acceptable for launch per the NSTS-08303 criteria. (The problem exists through end item EI-66. The mold will be changed to add more foam for EI-67 and subs. An EI spec waiver will be issued for STS-45 and subs until existing end items are expended. STS-42's umbilical will be approved for use by local PMRB.)

A small amount of ice/frost had formed around the LH2 umbilical aft pyrotechnic canister closeout. Thin foam exists in this area due to an incorrect mold manufacture. The amount and location of the ice/frost was acceptable for launch per NSTS-08303. The mold will be changed to add more foam to this area.

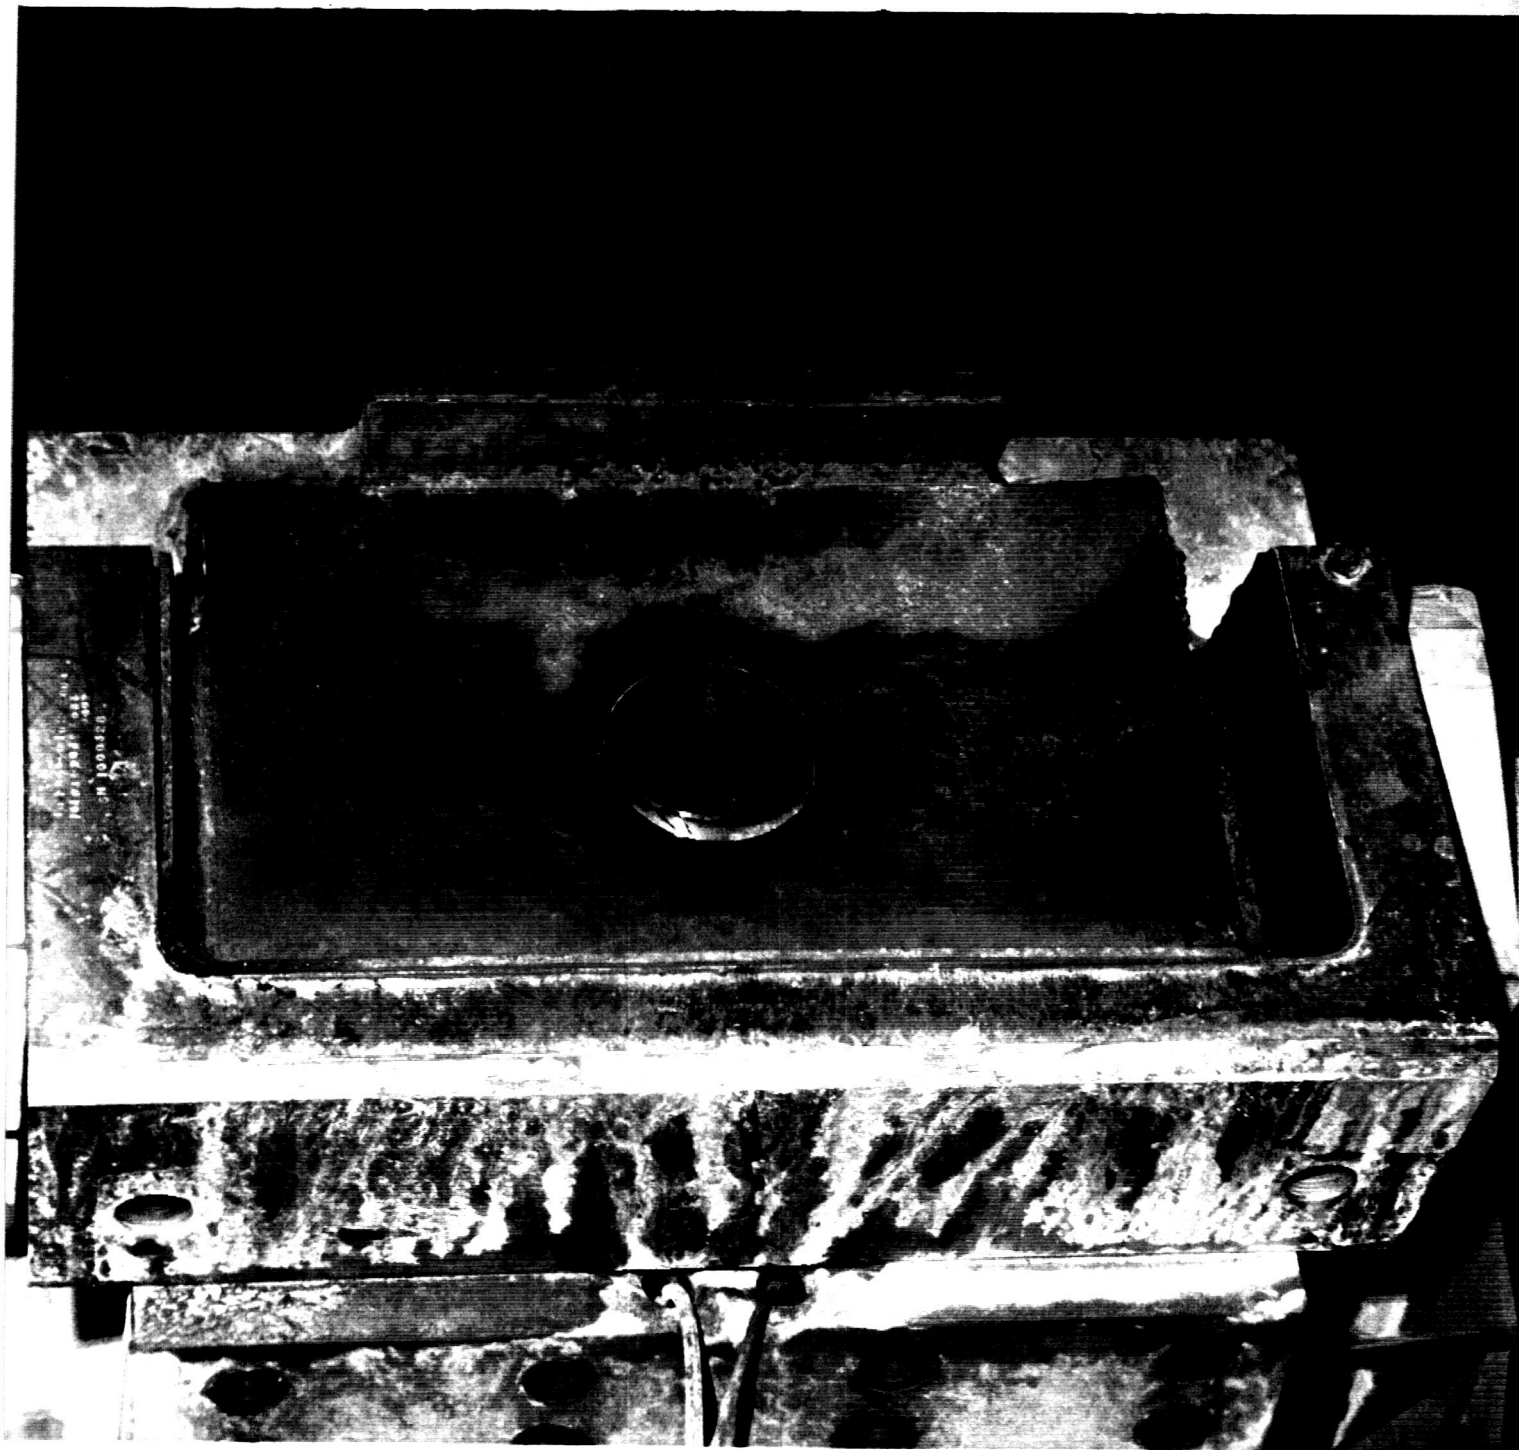
Plume erosion of the south SRB holddown posts was typical. All EPON shim material was intact, but slightly debonded from the holddown post shoe sidewalls on HDP #1 and #5. There was no visual indication of a stud hang-up on any of the south holddown posts.

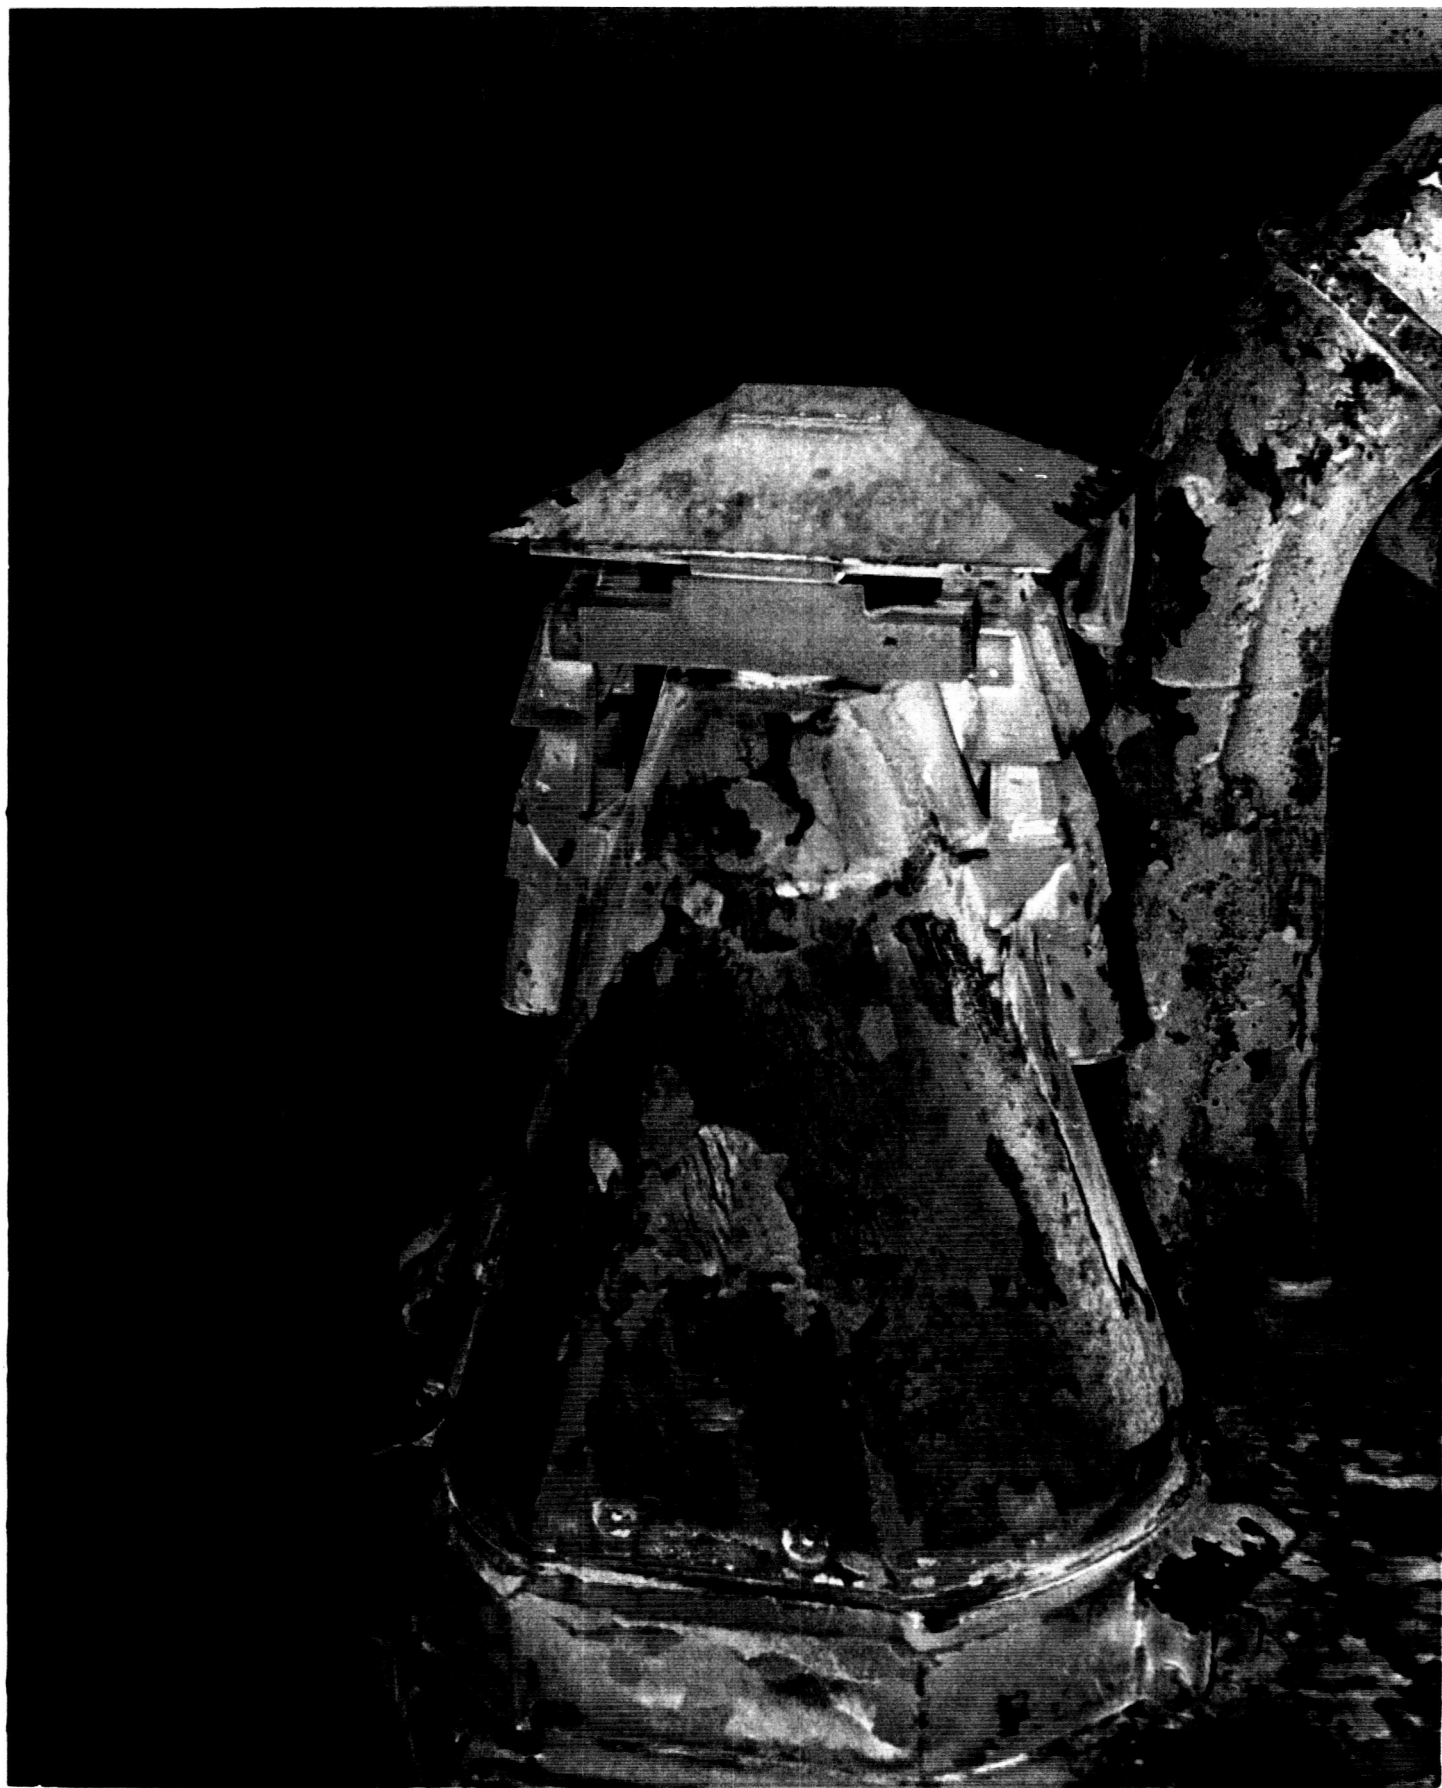
North HDP blast covers were in the closed position and exhibited typical SRB plume erosion effects
